FINAL PROJECT REPORT

Southeast USA Chemical Plant

High Velocity Oil Flush, System Decontamination
and Fluid Purification

Steam Turbine Generator, IR Compressor
and Expander

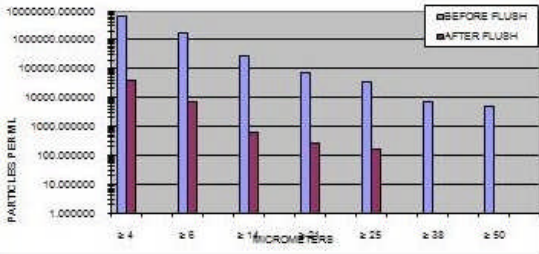
ISO 4406 PARTICLE COUNT ANALYSIS

FINAL FLUID ANALYSIS	FLUSH START	AFTER FLUSH	START COUNT	END COUNT
Appearance	Dark	Amber	<small>23/21/19</small> <small>NAS CLASS 1 PH 30.0% @ 25°C SAMPLE VOLUME 5mL</small>	<small>16/14/10</small> <small>NAS CLASS 2 PH 30.0% @ 25°C SAMPLE VOLUME 5mL</small>
System Appearance	Contaminated	Clean		
Large Solids Present	Yes	No		
Small Solids Present	Yes	No		
Water Content	Moderate	None		
Laser Particle Count	23 / 21 / 19	16 / 14 / 10		
Particle Size Range	Counts / mL	Code		
4 Microns	6357897.000	23	37733.000	16
6 Microns	1793554.000	21	6749.000	14
14 Microns	271938.000	19	641.000	10
21 Microns	67171.000	17	255.000	9
25 Microns	32700.000	16	154.000	8
38 Microns	7434.000	13	0.000	0
50 Microns	4801.000	13	0.000	0

BEFORE FLUSH (Blue bars), AFTER FLUSH (Red bars)

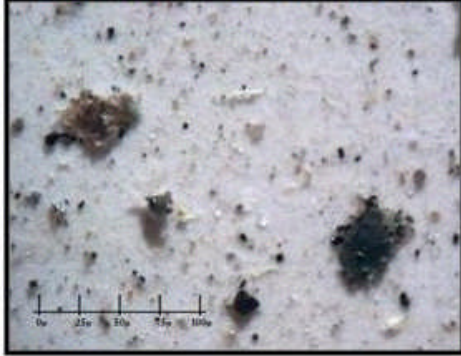
BEFORE HIGH VELOCITY FLUSHING - 100x

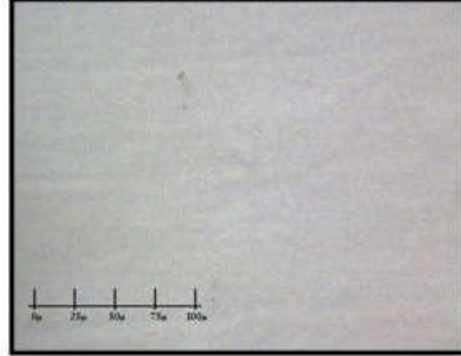
AFTER HIGH VELOCITY FLUSHING - 100x

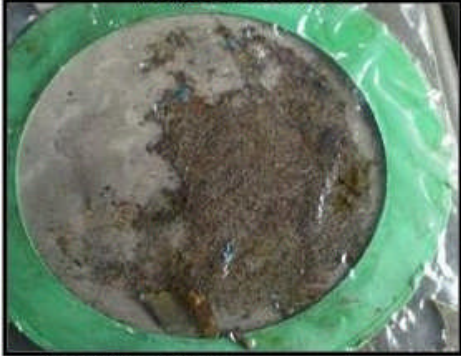
INITIAL SCREEN RUN

SCREEN SIZE: **3 inches**
LOCATION: **Down stream- Most Return Line Point**
SCREEN MATERIAL: **316L STAINLESS STEEL**
MESH: **100**
MICRON RATING: **149**
FLOW RATE (USGPM): **416 USGPM**
TOTAL FLOW (USG): **49920 USG**
SCREEN RATING (1-5): **4**
PASS / FAIL: **FAIL**
CUSTOMER WITNESS: **YES**

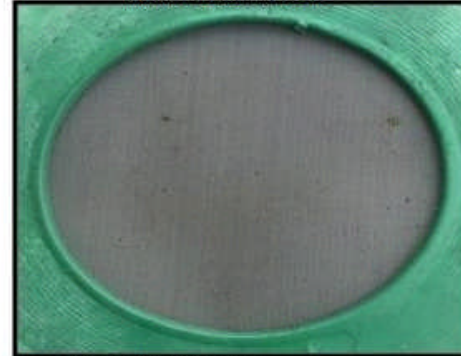
FINAL SCREEN RUN

SCREEN SIZE: **3 inches**
LOCATION: **Down stream- Most Return Line Point**
SCREEN MATERIAL: **316L STAINLESS STEEL**
MESH: **100**
MICRON RATING: **149**
FLOW RATE (USGPM): **416 USGPM**
TOTAL FLOW (USG): **99840 USG**
SCREEN RATING (1-5): **1**
PASS / FAIL: **PASS**
CUSTOMER WITNESS: **YES**

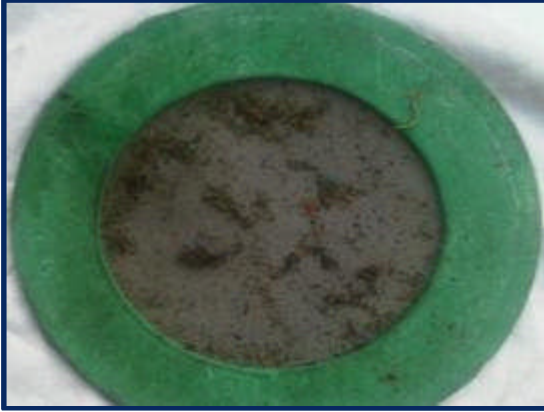
Screen from reservoir, Rating 4

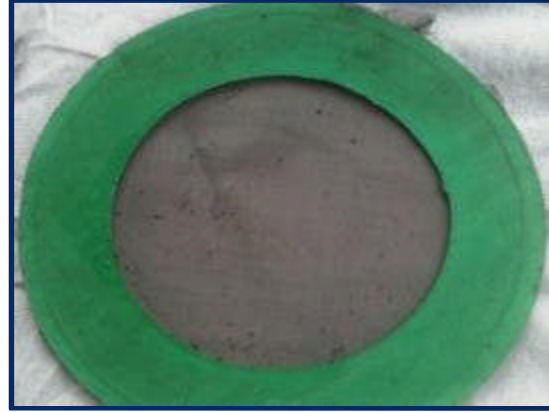
Screen from reservoir, Rating 1

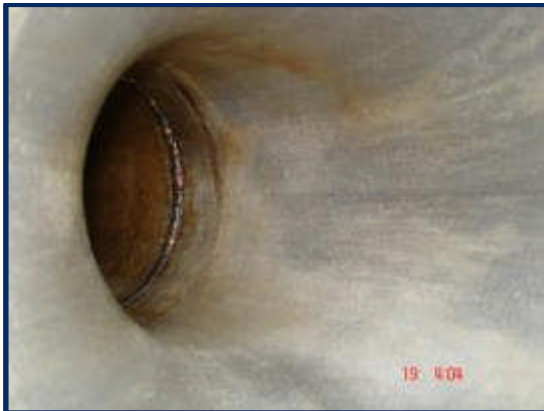
This is an internal view of the pipes, pre IAS.

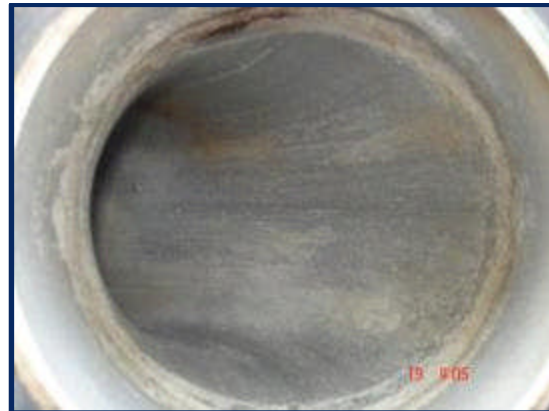
This is an internal view of the pipes, post IAS.

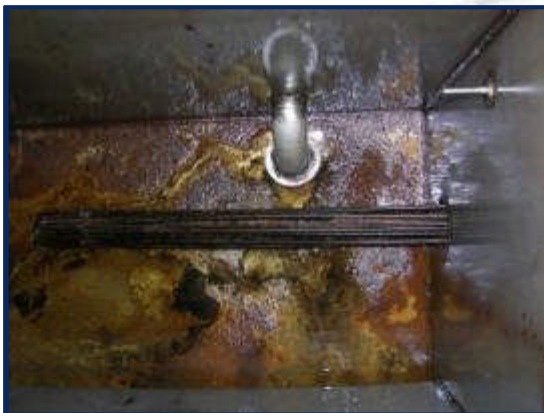
This is an internal view of the reservoir, pre IAS.

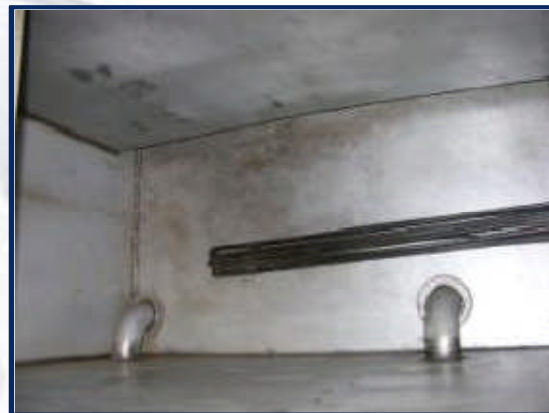
This is an internal view of the reservoir, post IAS.
