Rolls Royce Gas Engine

**High Velocity Hot Oil Flush & Chemical Flush
System Decontamination and Purification Project Report
April 2010**

Prepared by: Eric Levitt Reliable Contamination Control LLC

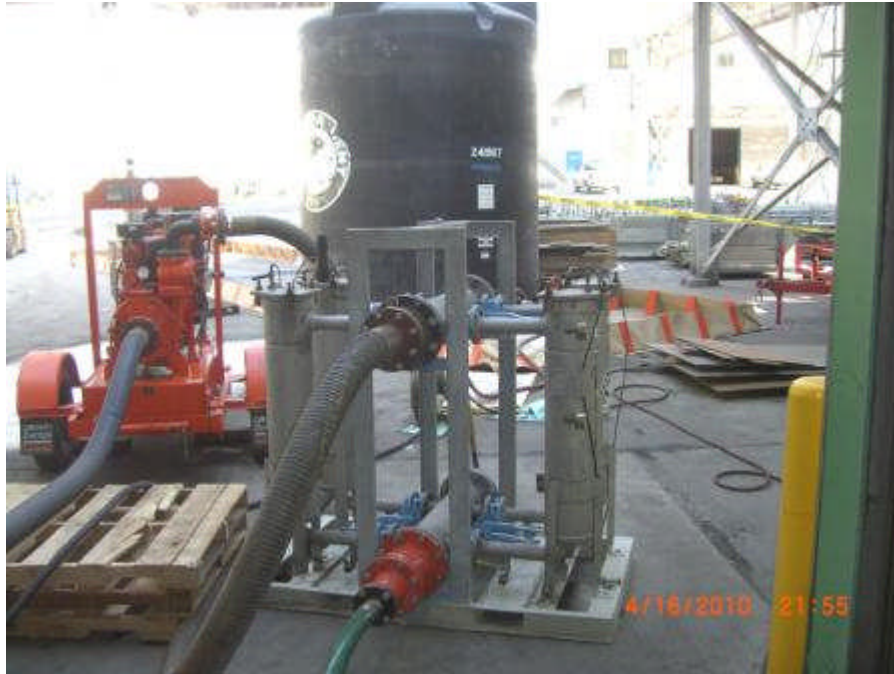
EQUIPMENT SET UP – CHEMICAL FLUSH

Non hazardous flushing chemicals were approved for use by the customer's EH&S department. The entire lube oil system was chemically cleaned so was the oil cooler, 60 gallon oil reservoir and oil piping

The process for chemical cleaning was

1. Degrease the system
2. Rinse with plant water
3. Chelation
4. Neutralization
5. Passivate

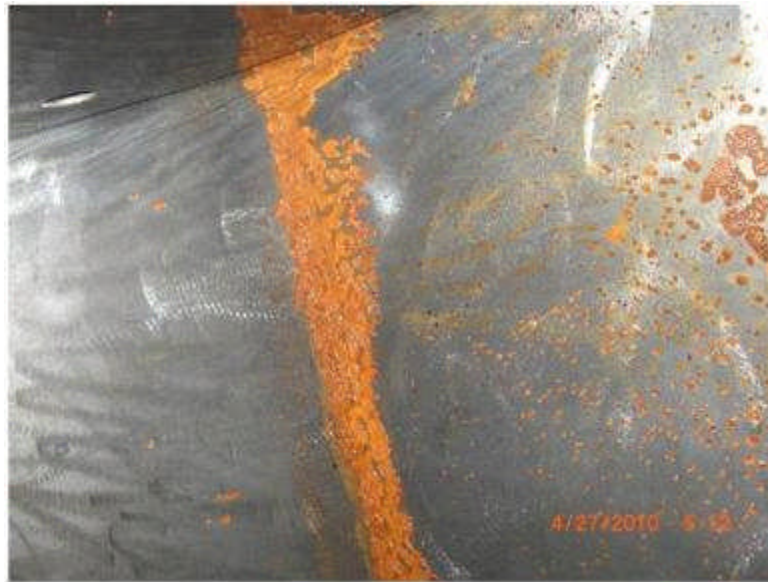
Internal of 60 gallon reservoir before chemical flush

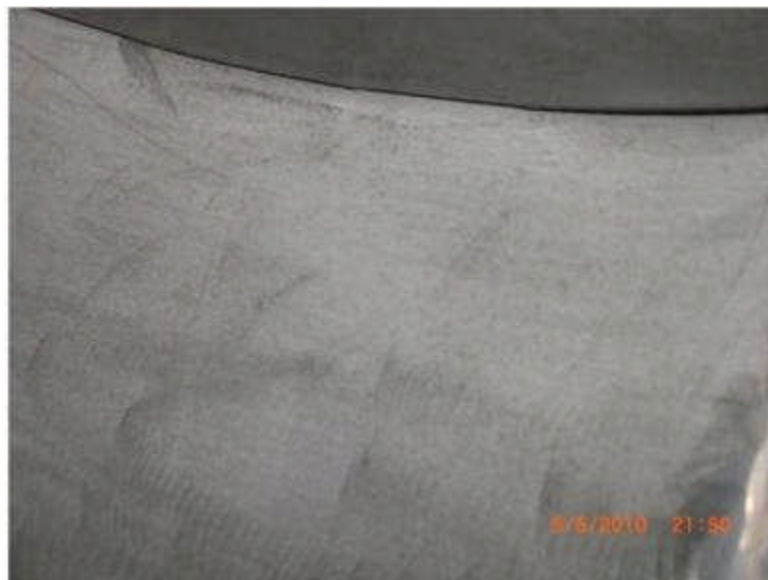
Internal of 60 gallon reservoir after chemical flush

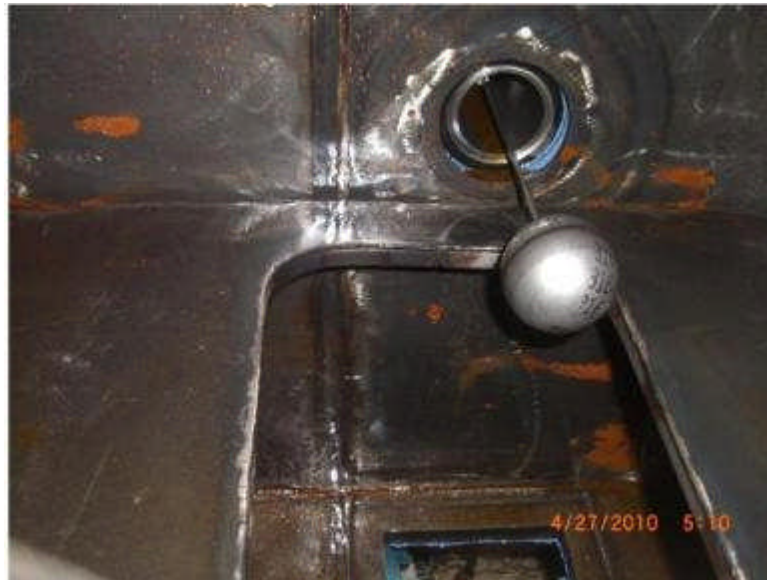
Internal of 60 gallon reservoir before chemical flush

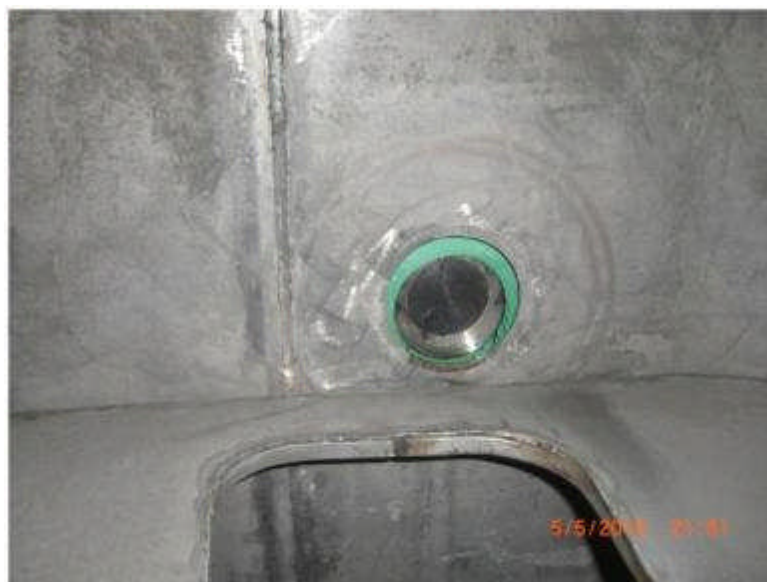
Internal of 60 gallon reservoir after chemical flush

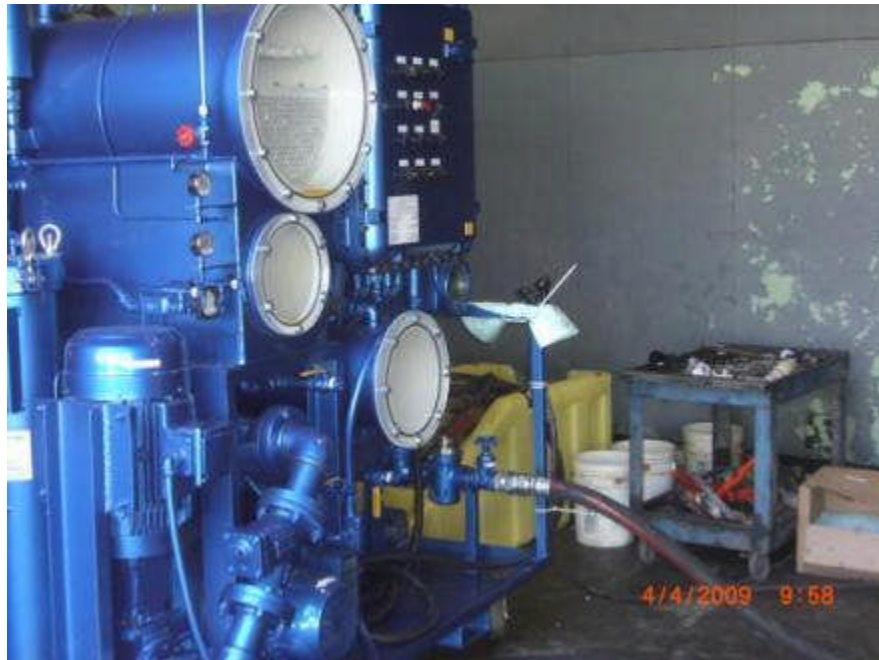
Oil Flush Equipment

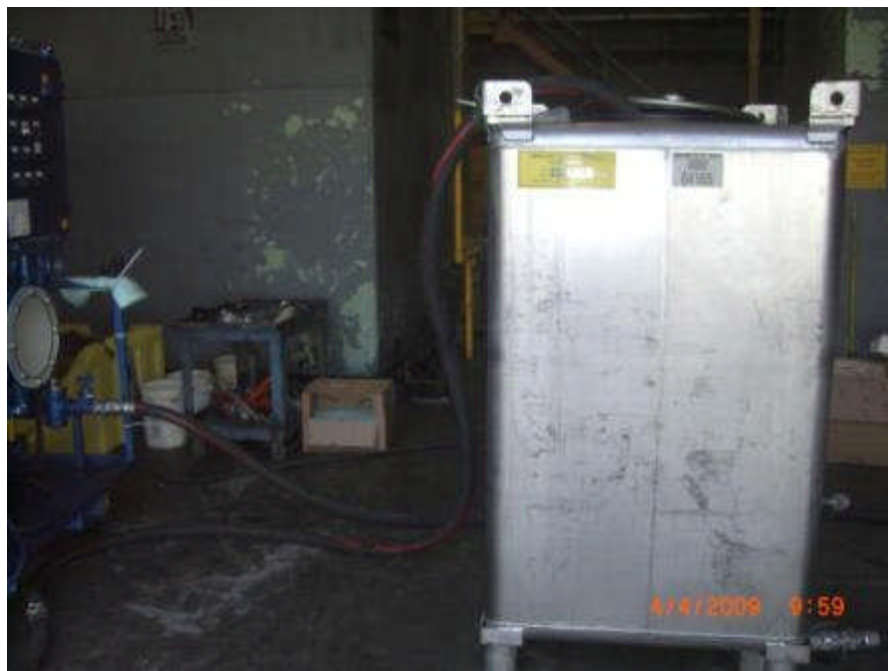
Temporary Oil Flush Reservoir

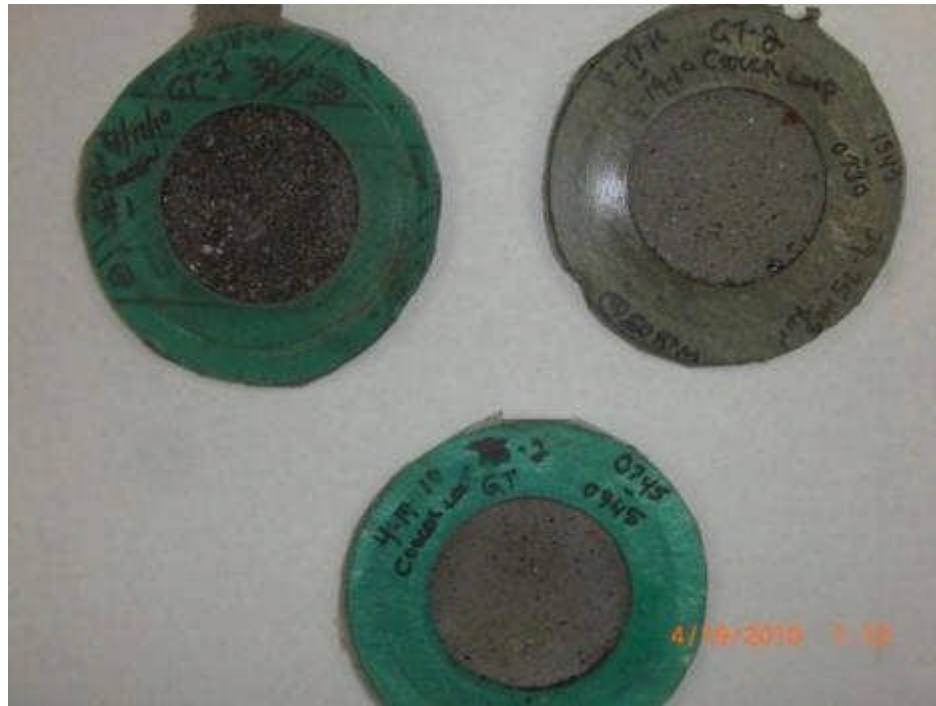
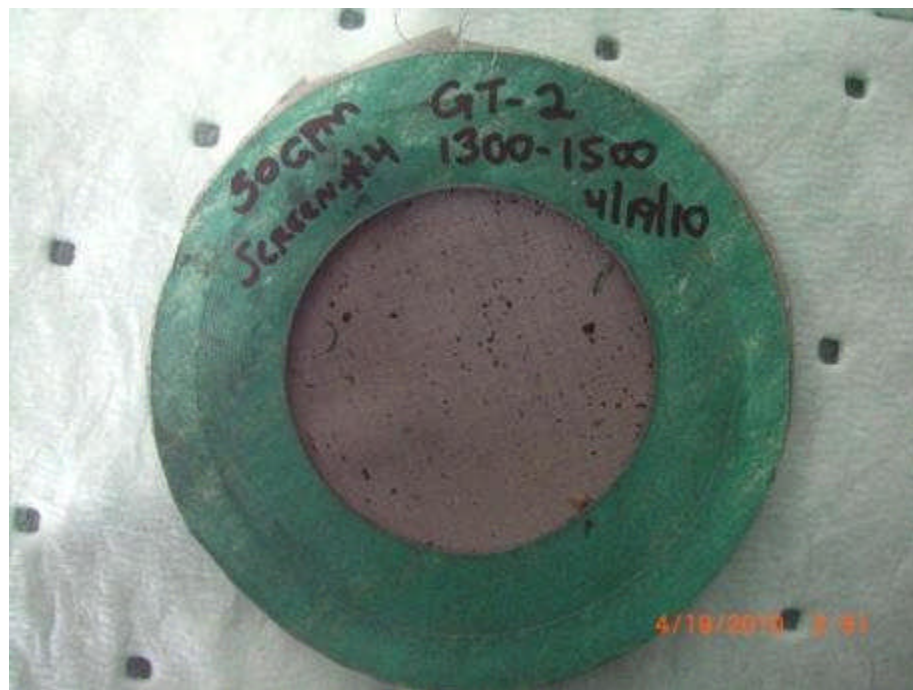
Oil Flush Proving Screens

Final Screen Photo Not Available
Approved by Customer on May 8, 2010 at 0700
