ESP Technology

Electrophysical Separation Process

Turbine Oil Varnish Mitigation

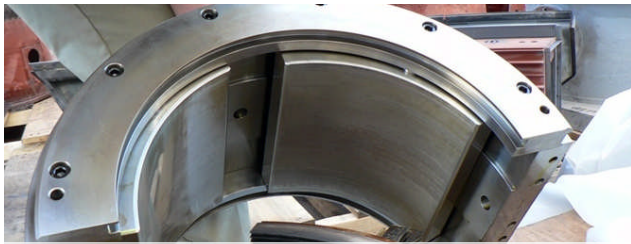
Clean Bearing Pads found After ESP Installation

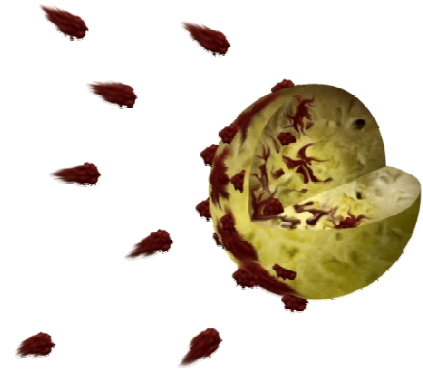
Rapid attraction and retention of varnish-producing contaminants

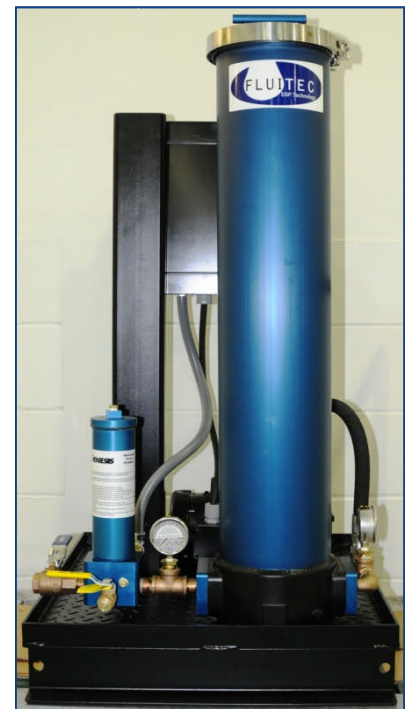
ESP 136 being installed on a Frame 6B

The ESP Products are designed to be either permanently installed (ESP-136) or rotated around to various lubrication assets at your plant (ESP-336). Each system integrates ergonomics with the highest manufacturing integrity. The system has been engineered for simple installation, operation and maintenance; whether you're installing it on a large frame peaking gas turbine or small base-loaded steam turbine system.

ESP-136	SP-336
Length	24"	40"
Width	24"	24"
Height	48"	48"
Weight	500 lbs	800 lbs
Power	115V, 6A, Single Ph	460V, 2A, 3-Ph
Flow Rate	0.6gpm	2.8gpm
Motor	1/3 HP	1 HP
Inlet/Outlet Connection	½" NPT	¾" NPT
Drain	¼" NPT	½" NPT
Seals	Buna-N	
Enclosure	TEFC	
Additional Filtration	5-µm Post Filter	5-µm Post Filter
Other features	Sampling ports, sensor-ready	
Reservoir Size	30,000 liters	80,000 liters
(Depends upon oil type, contamination and application)	Designed for permanent installation.	Designed to treat multiple reservoirs at one site.
Viscosity Range	22-68cSt @ 40°C	
Preferred Fluid Temp	40 – 70°C

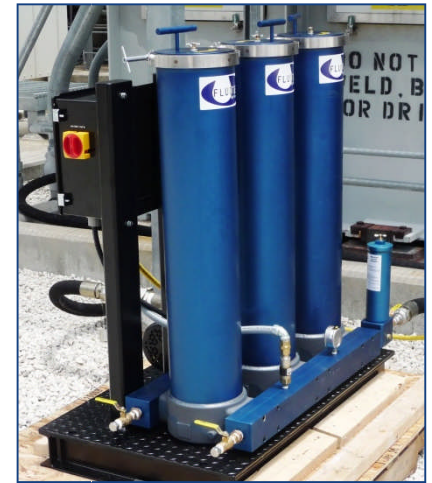
ESP-336 on a GE 7FA Unit

This large frame GE 7FA peaking plant had problematic IGV valve performance, resulting in costly fail-to-start conditions and unit trips. The plant had electrostatics already installed and had tried depth media filters to no avail. Within a week after installed Fluitec's ESP-336 System, their varnish problems disappeared and their oil was returned to normal level.

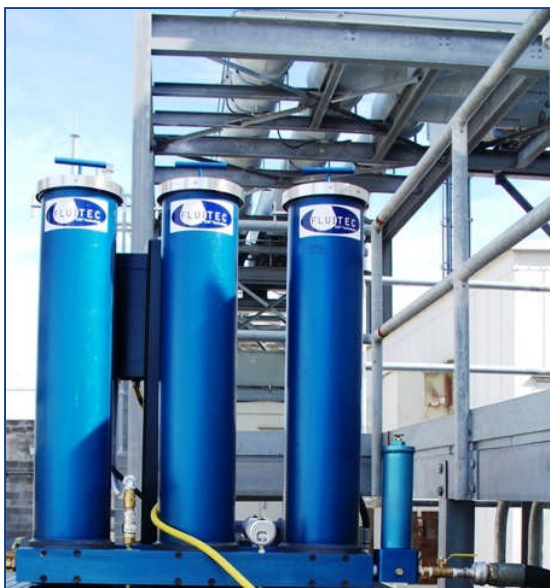
ESP-336 being rotated around a combined cycle plant to maintain 4 turbine oil reservoirs

The plant already had an "agglomeration" system installed but still had unacceptable varnish potential values. They decided to use Fluitec's ESP-336 unit to rotate through-out their 3 GTs and one ST, where all of their oil is now in "normal" condition. More importantly, the plant's reliability increased from 94% to 100% and the plant's personnel are now on track to receive all of their scheduled bonuses.
